# Manhole Inspection Summary

Manhole # S55I\_\_009MH

**Location** Address: **3800 eastern ave**

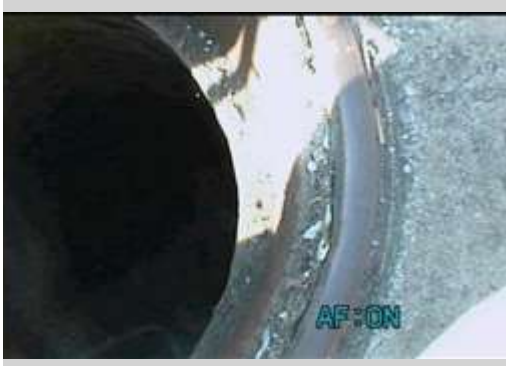
Defect 1

Offset: **2** (in.)

offset

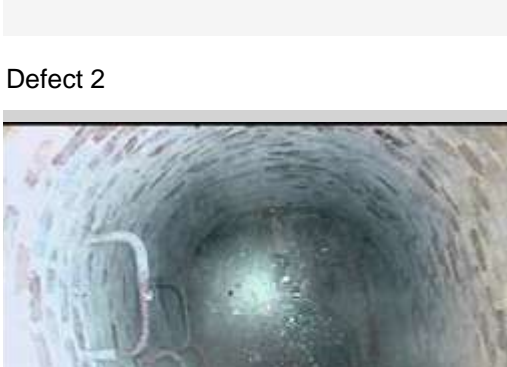
Channel Debris

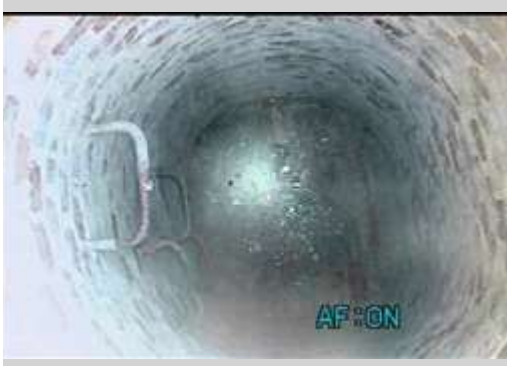
Defect 2

Count: **4** Missing: **1** ☒ **Corroded**

steps

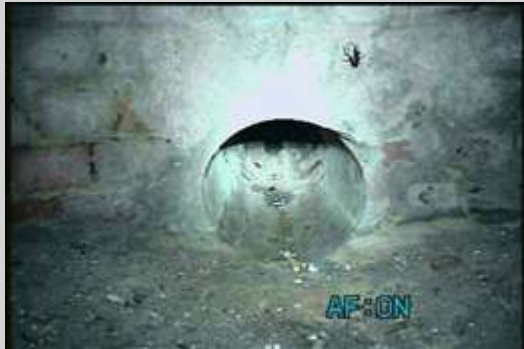
12 O'Clock Outflow

8 in. Circular Gravity Sewer  
Pipe Out @ 12 O'Clock

Pipe Material: **Clay** ☐ Pipe Lined

Invert Depth: **9.43** (ft.) Flow Characteristics: **Fast**

Deposits: ☒ None ☐ Mud ☐ Sludge ☐ Debris ☐ Grease

Infiltration: **None** Pipe Seal Cond: **Unknown**
